DEPARTMENT OF TRANSPORTATION

Quality Assurance and Source Inspection

Contract #: 04-0120F4Cty: SF/ALA Rte: 80 PM: 13.2/13.9File #: 69.28**WELDING INSPECTION REPORT****Resident Engineer:**Pursell, Gary**Address:** 333 Burma Road**City:** Oakland, CA 94607**Report No:** WIR-009641**Date Inspected:** 16-Oct-2009**Project Name:** SAS Superstructure**OSM Arrival Time:** 700**Prime Contractor:** American Bridge/Fluor Enterprises, a JV**OSM Departure Time:** 1900**Contractor:** Zhenhua Port Machinery Company, Ltd (ZPMC), Changxing Island **Location:** Shanghai, China**CWI Name:** Chen Ying Xin, Feng Guo.**CWI Present:** Yes No**Inspected CWI report:** Yes No N/A**Rod Oven in Use:** Yes No N/A**Electrode to specification:** Yes No N/A**Weld Procedures Followed:** Yes No N/A**Qualified Welders:** Yes No N/A**Verified Joint Fit-up:** Yes No N/A**Approved Drawings:** Yes No N/A**Approved WPS:** Yes No N/A**Delayed / Cancelled:** Yes No N/A**Bridge No:** 34-0006**Component:** Tower**Summary of Items Observed:**

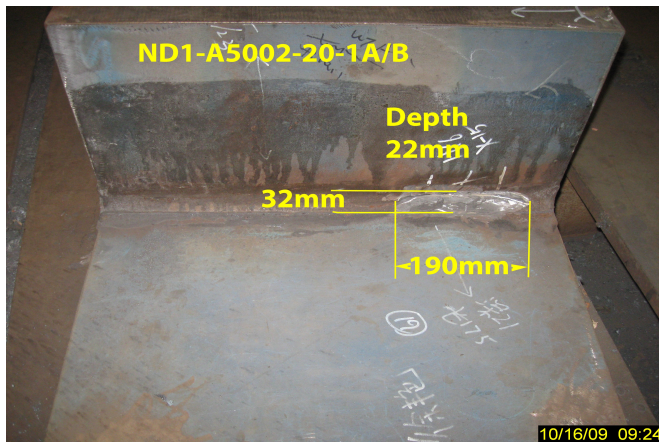
During random visual inspection, Caltrans Quality Assurance (QA) Inspector observed the excavated area on weld # ND1-A5002-20-1A/B of Angle plate. This area had been rejected by ultrasonically by ZPMC NDT personnel.

The attached photographs provide additional detail.
